## Systems of information, information nets, and information black holes

## An Information Black Hole

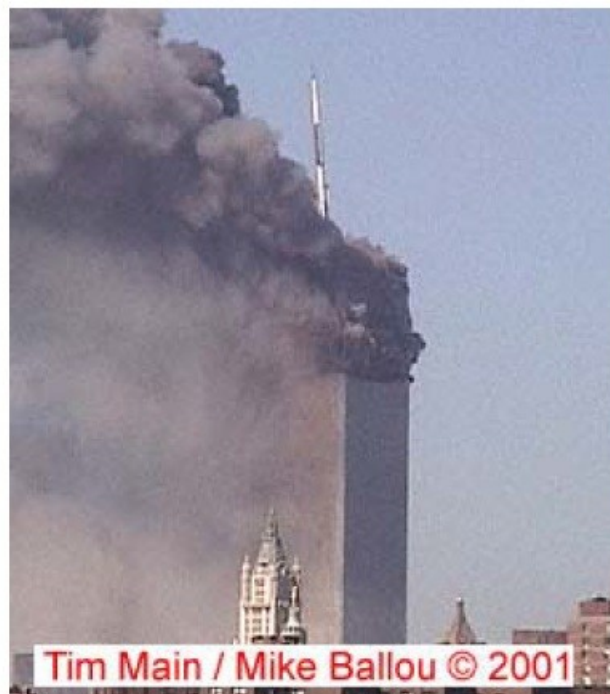
Figure 5-8 is shown below:

**Figure 5–8. Collapse initiation and tilting of WTC 1 (view from the northeast).**

"The section of the building above the impact zone tilted to the south (observed at about 8 degrees) as column instability progressed rapidly from the south wall along the adjacent east and west walls (see figure E-11), resulting in increased gravity load on the core columns." - page liv

(fig E-11 is the same as fig 5-8 shown below)

" The section of the building above the impact zone began tilting to the south (observed at 8 degrees, table 5-2) as column instability progressed rapidly from the south wall along the adjacent east and west walls (see fig 5-8) resulting in increased gravity load on the core columns. The change in potential energy due to downward movement of building mass above the buckled columns exceeded the strain energy that could have been absorbed by the structure. Global collapse ensued." - p 314

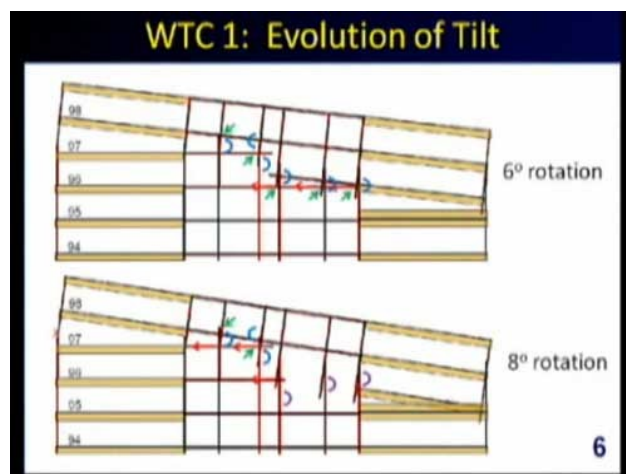
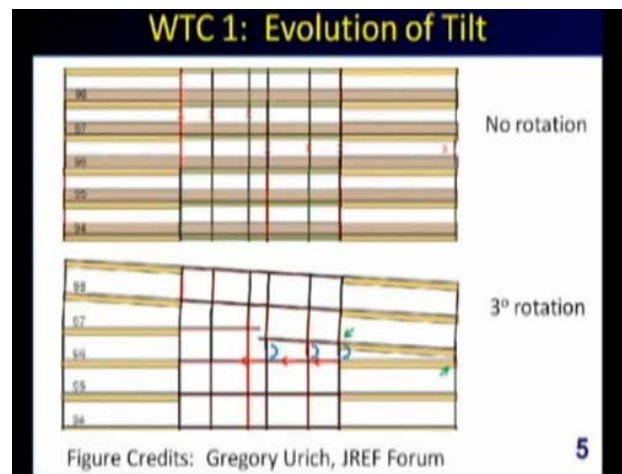
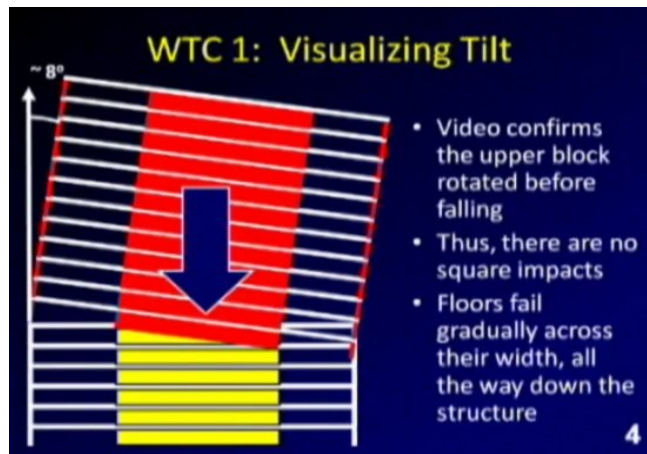
Two professional engineers drew the diagrams below to describe the collapse initiation movement for the North Tower during internet forum discussions:

It is obvious that they simply read the NIST quotes on the North Tower and drew what the NIST wrote. Their drawings match the NIST descriptions of the same movement. There is at least 8 degrees of tilt in both illustrations and both 'blocks' are tilting 'rigidly'. This was their understanding of what the NIST wrote in their final reports.

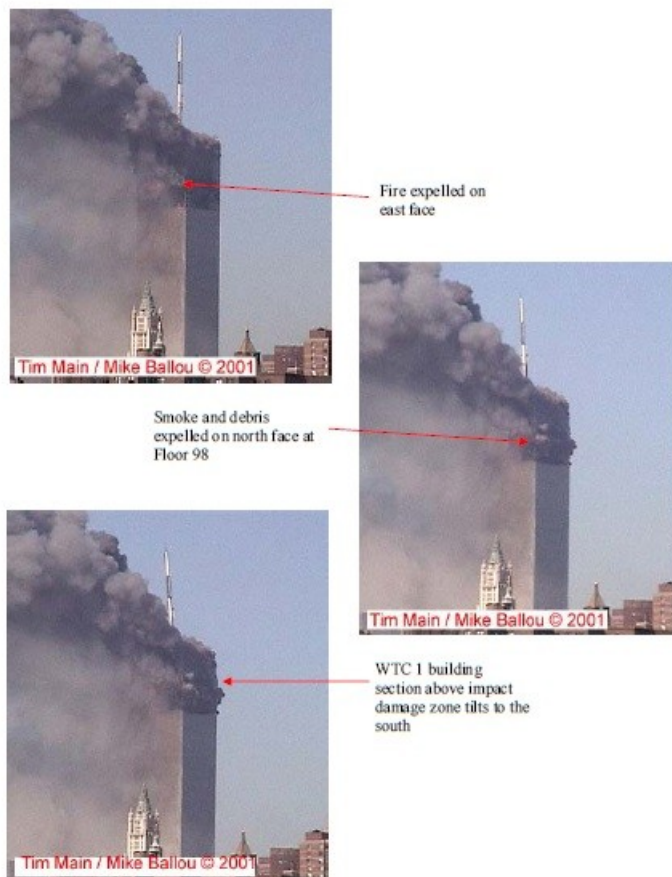
Figure 6-7. Expulsion of smoke and debris at WTC 1 Floor 98 on the east, north, and west faces.

Figure 6-7 shows how the NIST misrepresents the movement of the building as the columns originally failed. The earliest visible ejections actually emerge from the 95 floor along the west face. The northwest corner, the last group of columns to fail, had already failed by the time the second and third images were taken.

In this series of images and in each series to follow the NIST exaggerates the North Tower tilt angle by basically smearing out the column failure sequence far, far longer than is justified by any evidence. It is not clear that the NIST is using any systematic method at all to determine at which moment the last surviving columns on the northwest corner fail. The mappings and reconstructions linked earlier give a few precise techniques to determine the moment of failure of the northwest corner. Synchronized video then allows anyone to see the actual tilt motion during the column failure sequence. The NIST was incorrect by more than 800%.

In the following sequence all columns had failed before the second and third photographs were taken even though the NIST misrepresents the failures as occurring during the sequence shown:

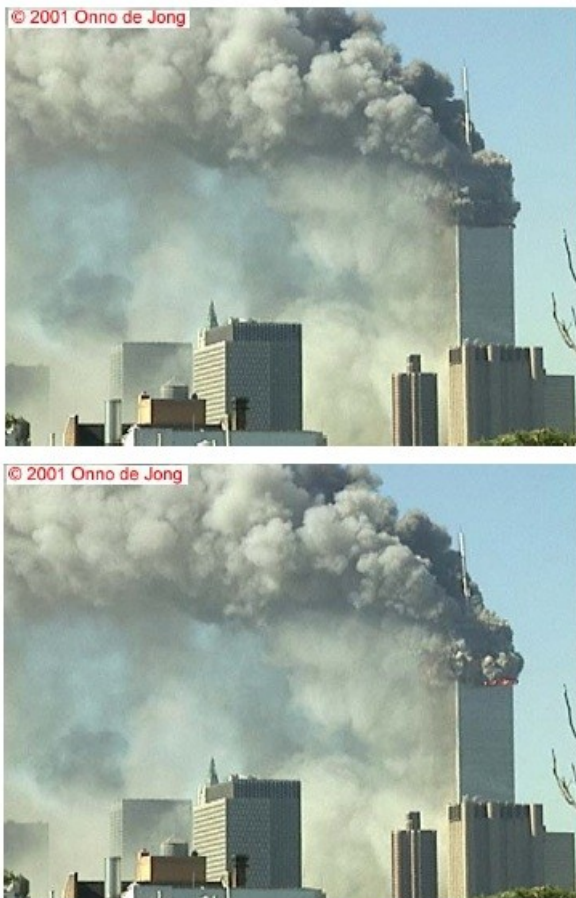
Figure 6-9. Smoke expulsion at Floor 98 from north and east faces at collapse initiation.

Figure 6-9 which shows how the NIST misrepresents the movement of the building as the columns originally failed. The northwest corner, the last group of columns to fail, had clearly failed by the time both of these images were taken.

Likewise, all columns had failed by the time the 2 photos below were taken:

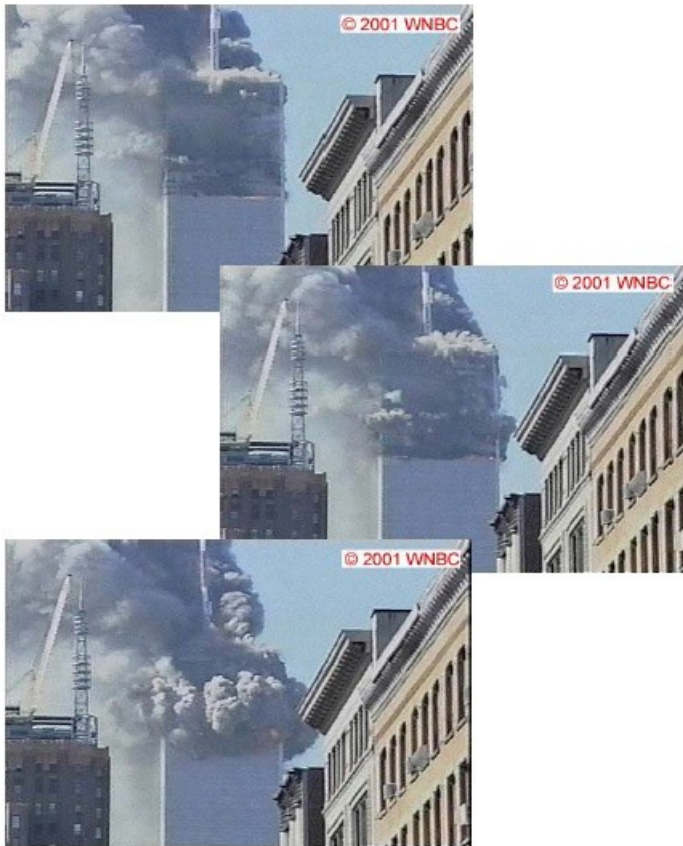
Figure 6-10. Rotation of WTC 1 building section above the aircraft impact zone toward the south as viewed from due north. Note that there is no tilt in the east or west directions.

Figure 6-10 which shows how the NIST misrepresents the movement of the building as the columns originally failed. The northwest corner, the last group of columns to fail, had clearly failed by the time the second and third images were taken.

Once again, all columns had clearly failed by the time the second and third photographs were taken (the failure of the northwest corner of the building (on the right) is visible to the naked eye in these photos):

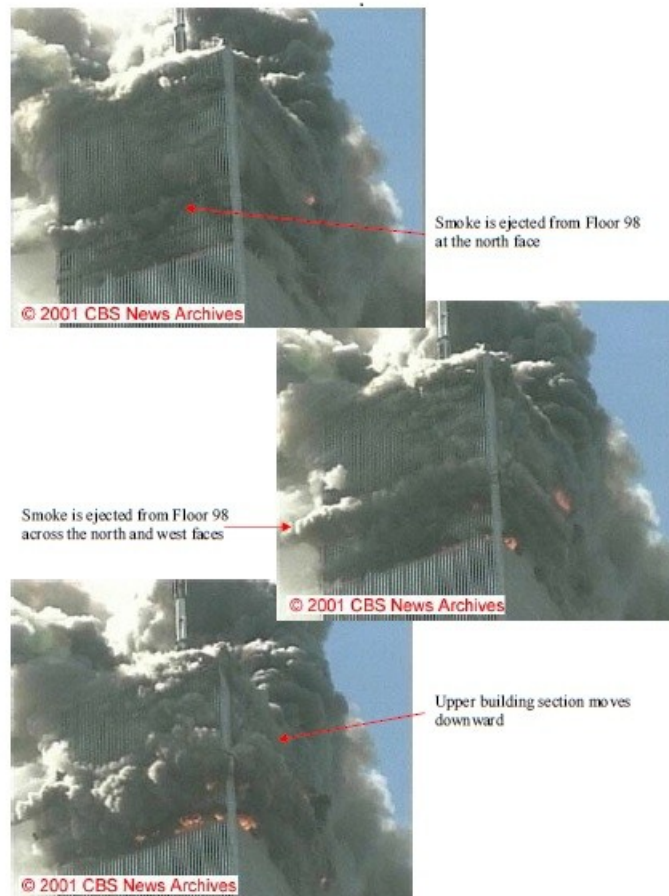
Figure 6-8. Smoke expulsion at Floor 98 from north and west faces as collapse initiates.

Figure 6-8 shows how the NIST misrepresents the movement of the building as the columns originally failed. The earliest visible ejections actually emerge from the 95 floor along the west face and are quite visible in video taken from this same viewing angle. The northwest corner, the last group of columns to fail, had already failed by the time the second and third images were taken (visible to the naked eye). The entire upper section was moving downward in the second and third images as measurements of the upper northwest corner clearly show. At the time the second and third images were taken, there were forceful smoke expulsions from the 88th floor, south face, 10 stories below the claimed collapse initiation area along the 98th floor and from the 77th floor, west face, over 20 floors below the 98th floor smoke expulsions shown by the NIST within these images.

Once again, all columns had completely failed by the time the second photo was taken:

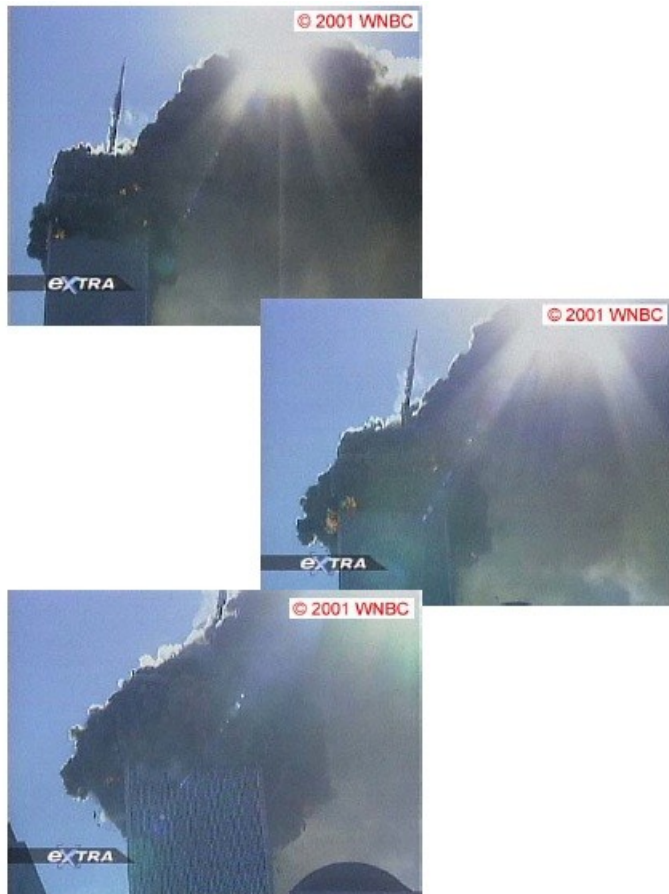
Figure 6-11. WTC 1 tilt to the south of approximately 8 degrees was measured before smoke and debris obscured view. Note view is from west and tilt is directly south.

Figure 6-11 which shows how the NIST misrepresents the movement of the building as the columns originally failed. The northwest corner, the last group of columns to fail, had already failed by the time all 3 of these images were taken. The upper section was actually collectively sliding southward in all 3 of these images.

In the next case all columns had completely failed before all 3 photographs were taken:
